Technical Report PolymerMetal®

TEC-# 030

High stress due to temperature, chemicals (aggressive lye) and erosion affecting at the same time

Experience report of a producer of aluminium oxide

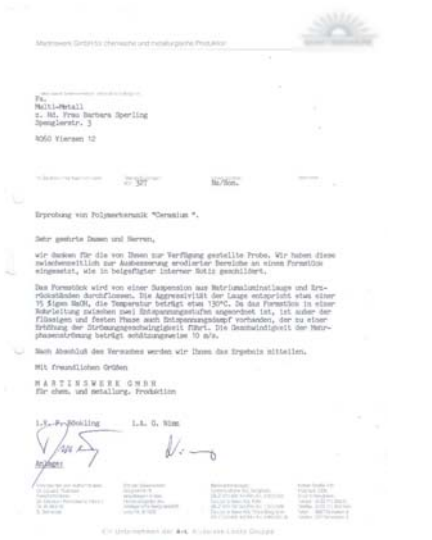
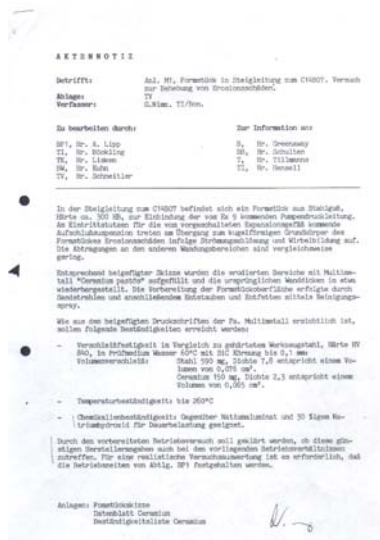
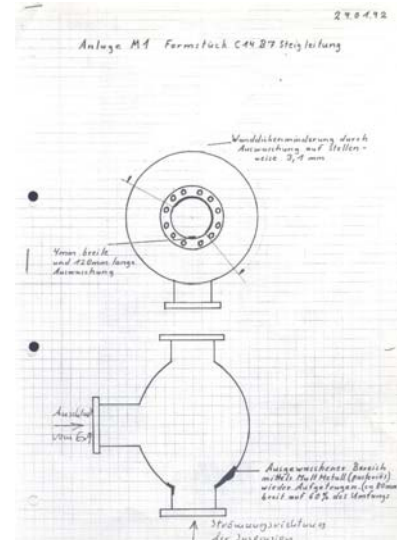
The standpipe to the C14B07 has a structural part made of steel casting of Brinell hardness 300. Damages were caused by erosion due to burbling and formation of whirls. According to the drawing on the right side the eroded areas were refilled with Ceramium® pasty. Therefore the original wall thickness was restored. The surfaces were sand blasted, made dust free and degreased before.

After appr. 4 months a revision was carried out. No visible erosion damages at the surfaces coated with Ceramium® were found. The areas of the steel casting which were not coated with Ceramium showed very severe erosion damages.
